Structural Health Monitoring (SHM) Study of Polymer Matrix Composite (PMC) Materials Using Nonlinear Vibration Methods Based on Embedded Piezoelectric Transducers

Article

Abstract: Nowadays, nonlinear vibration methods are increasingly used for the detection of damage mechanisms in polymer matrix composite (PMC) materials, which are anisotropic and heterogeneous. The originality of this study was the use of two nonlinear vibration methods to detect different types of damage within PMC through an in situ embedded polyvinylidene fluoride (PVDF) piezoelectric sensor. The two used methods are nonlinear resonance (NLR) and single frequency excitation (SFE). They were first tested on damage introduced during the manufacturing of the smart PMC plates, and second, on the damage that occurred after the manufacturing. The results show that both techniques are interesting, and probably a combination of them will be the best choice for SHM purposes. During the experimentation, an accelerometer was used, in order to validate the effectiveness of the integrated PVDF sensor.

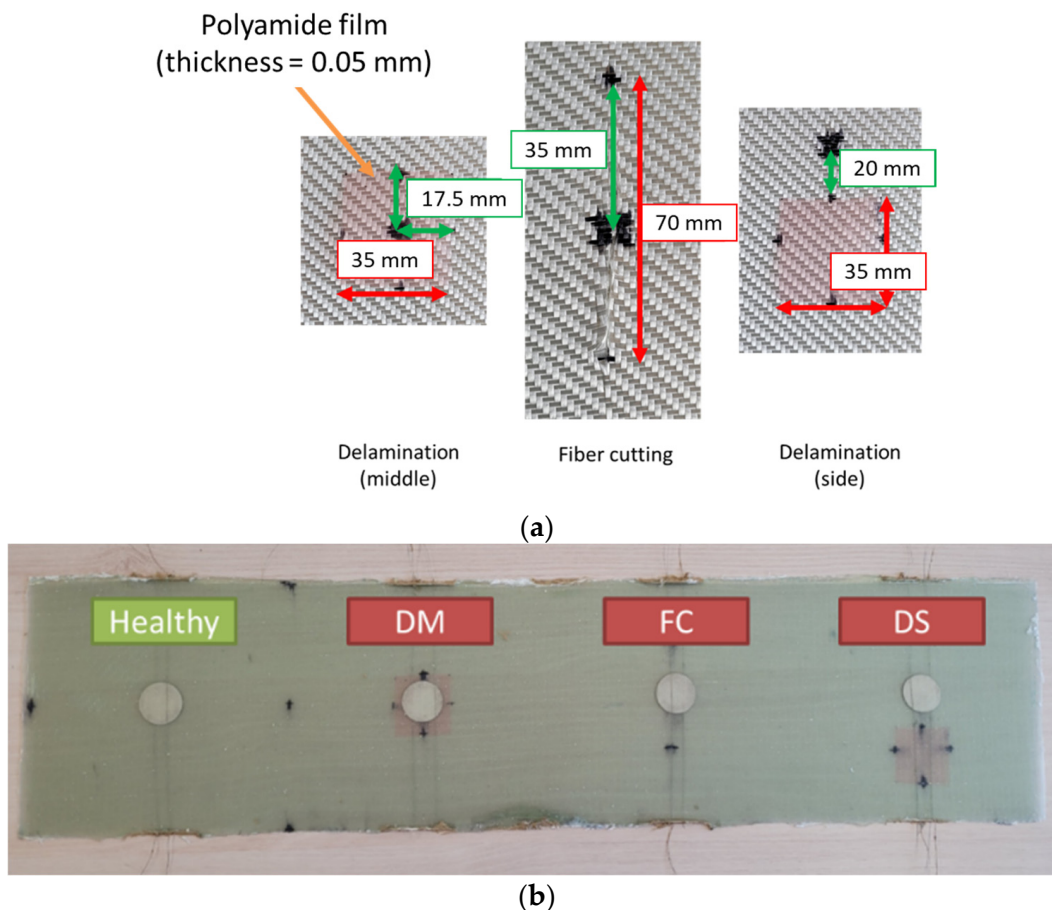
Figure 2. (a) Damage insertion and (b) manufactured plate before cutting.

In order to reduce the number of LRI operations, one big plate was manufactured with the dimensions of $620 \times 150 \times 1.5 \text{ mm}^3$ and then cut into four $150 \times 150 \times 1.5 \text{ mm}^3$ plates. One area of $150 \times 150 \text{ mm}^2$ was used as a healthy area while three others with the same dimension were used to create damage. Two delaminations were introduced by inserting $35 \times 35 \times 0.05 \text{ mm}^3$ polyamide film between plies 3 and 4 at two different positions: in the middle below the PVDF sensor (named DM) and on the side between the middle and the edge of the plate (named DS). One fiber cutting of 70 mm was made on the middle axis of the third ply. Each area has its integrated PVDF sensor in the middle plane (Figure 2).

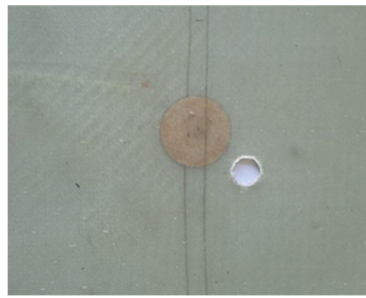
Figure 3. Smart PMC plate with a 10 mm diameter hole.

Once the LRI was finished and the cutting made, 4 smart PMC plates were usable for the vibration analysis. The vibration data were first obtained on the healthy plate. Later, a hole with an increasing diameter (1.5, 4, 6, 10 mm) was introduced with a series of vibration tests for each (Figure 3). The choice of the hole was made in order to easily compare with a numerical model. All the configurations are summarized in Table 1.

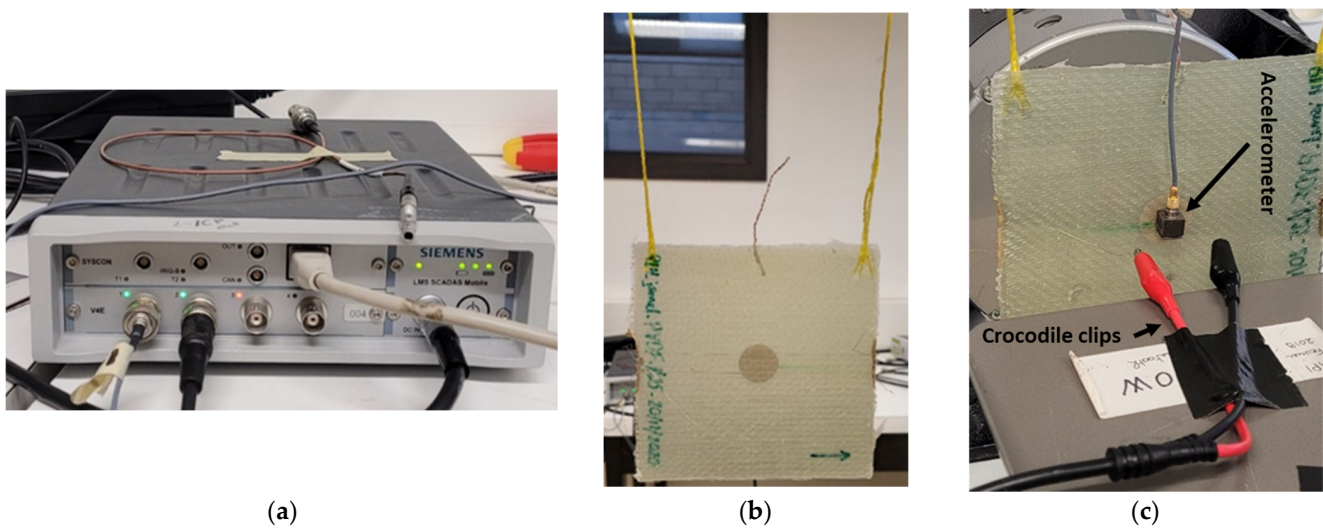
Figure 4. (a) Signal analyzer, (b) suspended plate, (c) crocodile clips and accelerometer.

To perform the vibration experimentation, the structure was suspended with two elastic threads in order to approximate the free-free boundary condition. The effectiveness of the PVDF as a vibration sensor has been tested and validated through several studies [33,34]. This work compared the results with those obtained by an accelerometer glued in the same position as the PVDF but on the surface. The output voltage of the PVDF was caught by two crocodile clips and connected to a signal analyzer (*Siemens—LMS Scadas mobile 01*). The equipment can be observed in Figure 4. This kind of analyzer directly manages the input and output data (fast Fourier transform (FFT) is automatically processed to visualize the result in the frequency domain) and allows observing the results in the Testlab software. It can also provide an electrical signal (signal generator). An electromechanical shaker (*Brüel & Kjaer—Modal exciter type 4824*) was used to excite the structure using a thin rod of 1mm diameter glued on the surface, in order to minimize surface excitation. In addition to this equipment, an amplifier (*Brüel & Kjaer—Power Amplifier Type 2732*) was used to provide the electrical signal delivered by the analyzer to the shaker. Figure 5 schematizes the experimental device used in the vibration tests.

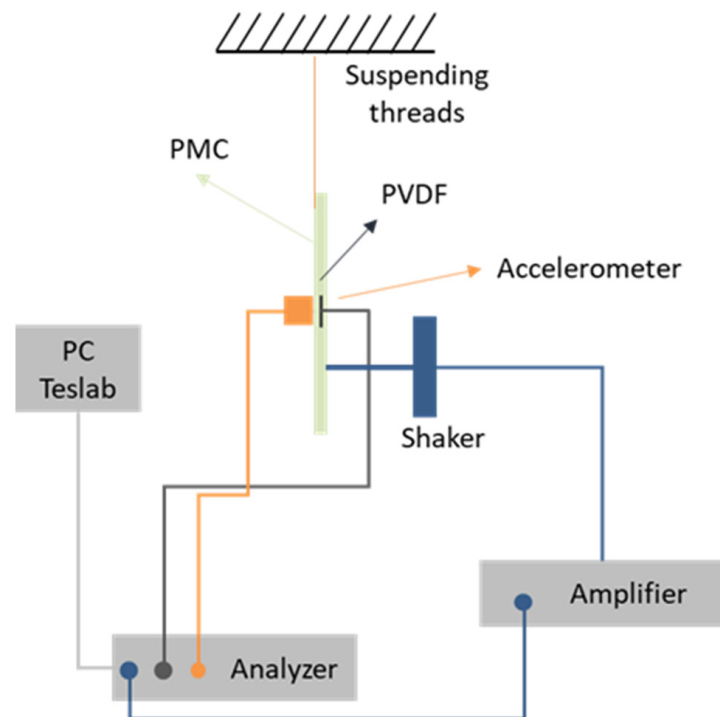
Figure 5. Schematic of the setup used for nonlinear vibration analysis.

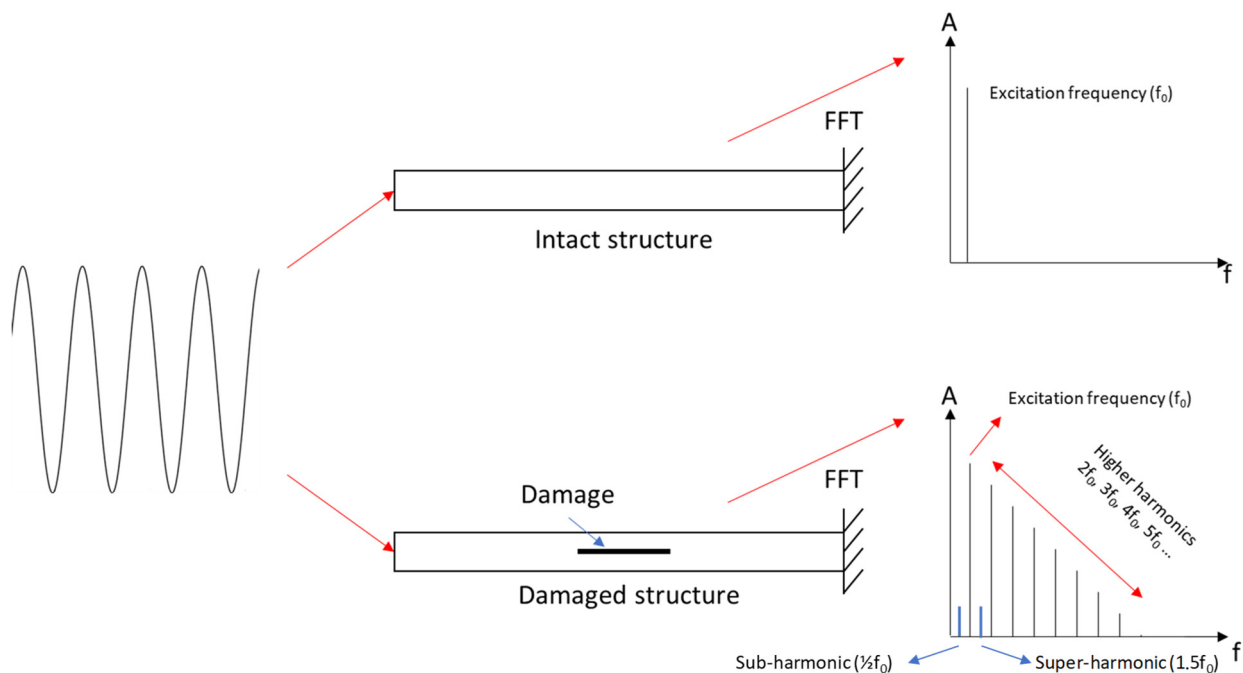
Figure 8. Sub- and super-harmonics generation method (adapted from [37]).

The sub- and super-harmonics generation method allows exciting the structure with a harmonic signal and observing only fundamental frequencies in the output of the healthy structure and a generation of sub- and super-harmonics in the damaged structure. Some researchers [36,37] used natural frequencies of the structure or a ratio of these natural frequencies (such as 1/3, 1/2, 2, etc.) as the frequency of excitation. In addition, two kinds of super-harmonics can be observed: the integer super-harmonics (2, 3, 4, etc.) and the super-harmonics built from a combination of the sub-harmonics and the integer super-harmonics (1.5, 2.5, 3.5, etc.) (Figure 8).

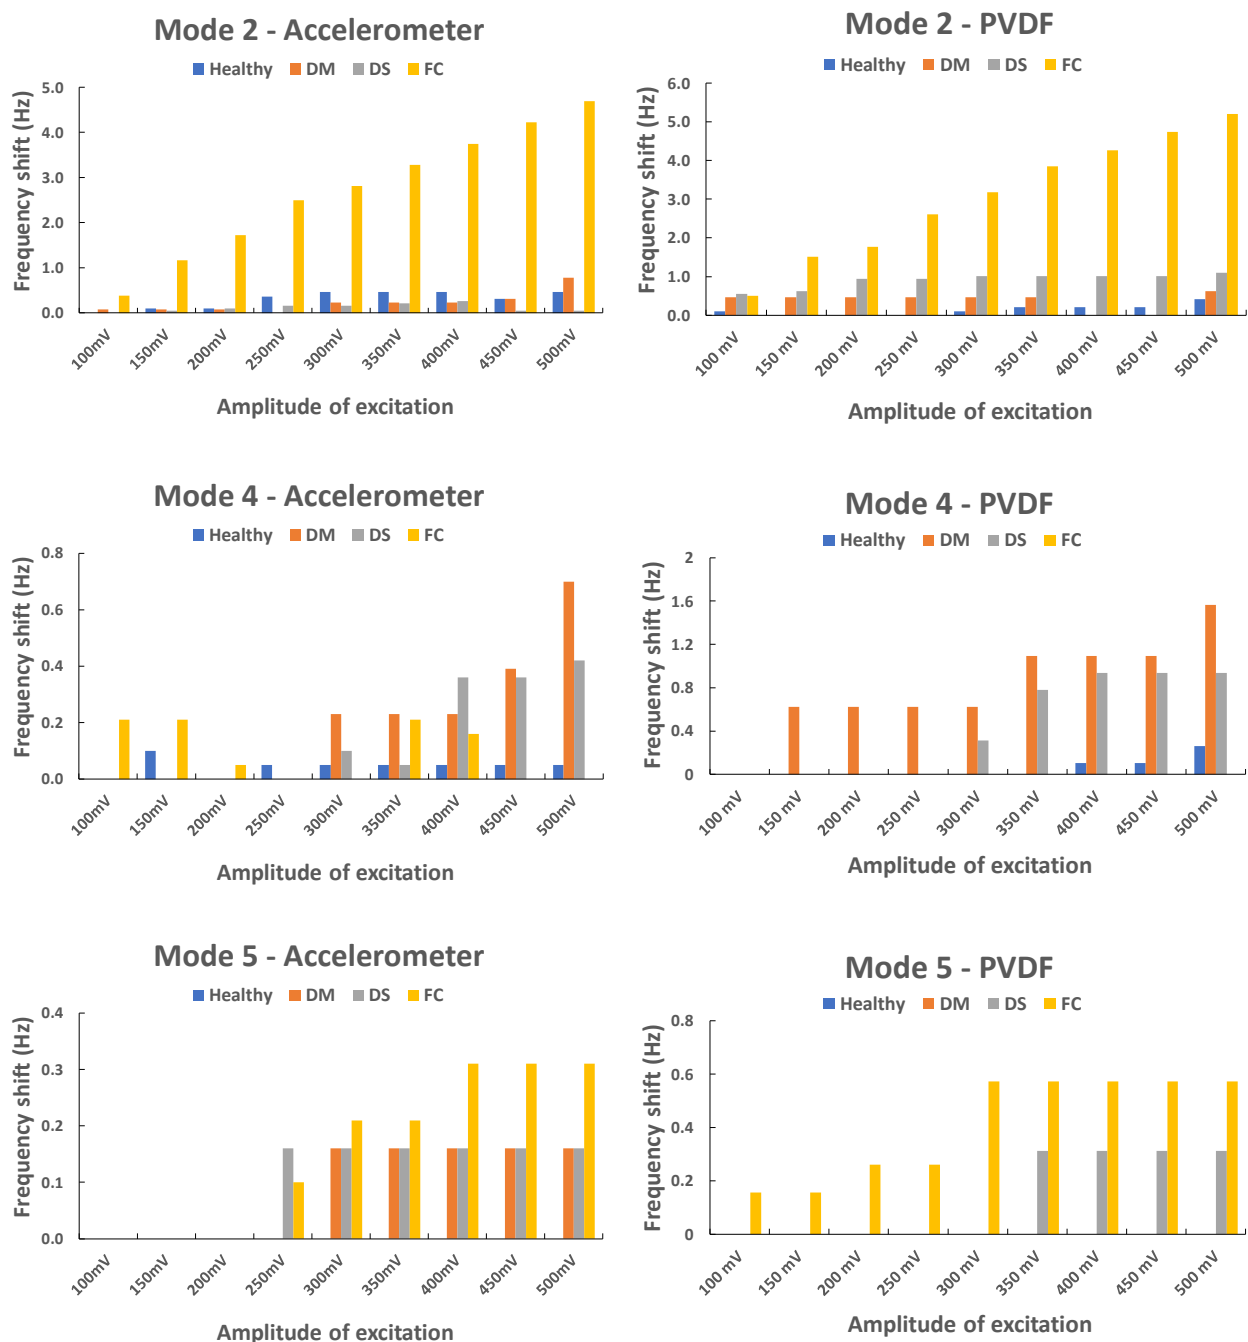
Figure 10. Frequency shift vs. amplitude of excitation: second, fourth, and fifth natural frequencies.

The DM, DS, and FC plates were compared with the healthy plate. However, the healthy plate for the first natural frequency showed a big shift, this is why this mode was not used for the comparison. Three modes (second, fourth, and fifth) showed interesting shifts (Figure 10).

The fiber cutting (FC plate) seemed to influence the vibration of the second and the fifth modes while the two delaminations (DM and DS plates) seemed to influence the fourth mode, especially DM. The second mode was investigated for the FC plate, and an interesting phenomenon was observed. Two peaks are observable for this mode with one showing a big shift in frequency, a loss around 5 Hz (Figure 11); this phenomenon is observable for both sensors and every repeated test. The second peak is observable for the sixth level of excitation (300 mV) and higher, which means the plate does not show this nonlinear behavior at a low amplitude of excitation.

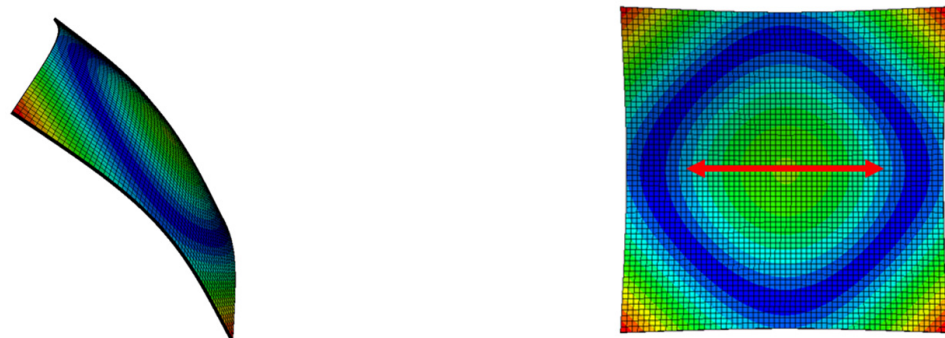
Figure 12. Second-mode shapes of a $150 \times 150 \times 1.5 \text{ mm}^3$ plate from Abaqus software. (Red arrow = FC).

In the second mode, the vibration bends the plate area inside the blue “circle” in Figure 12, which corresponds to the fiber cutting location. This could create the nonlinearities in the vibration of the plate observed in Figure 11.

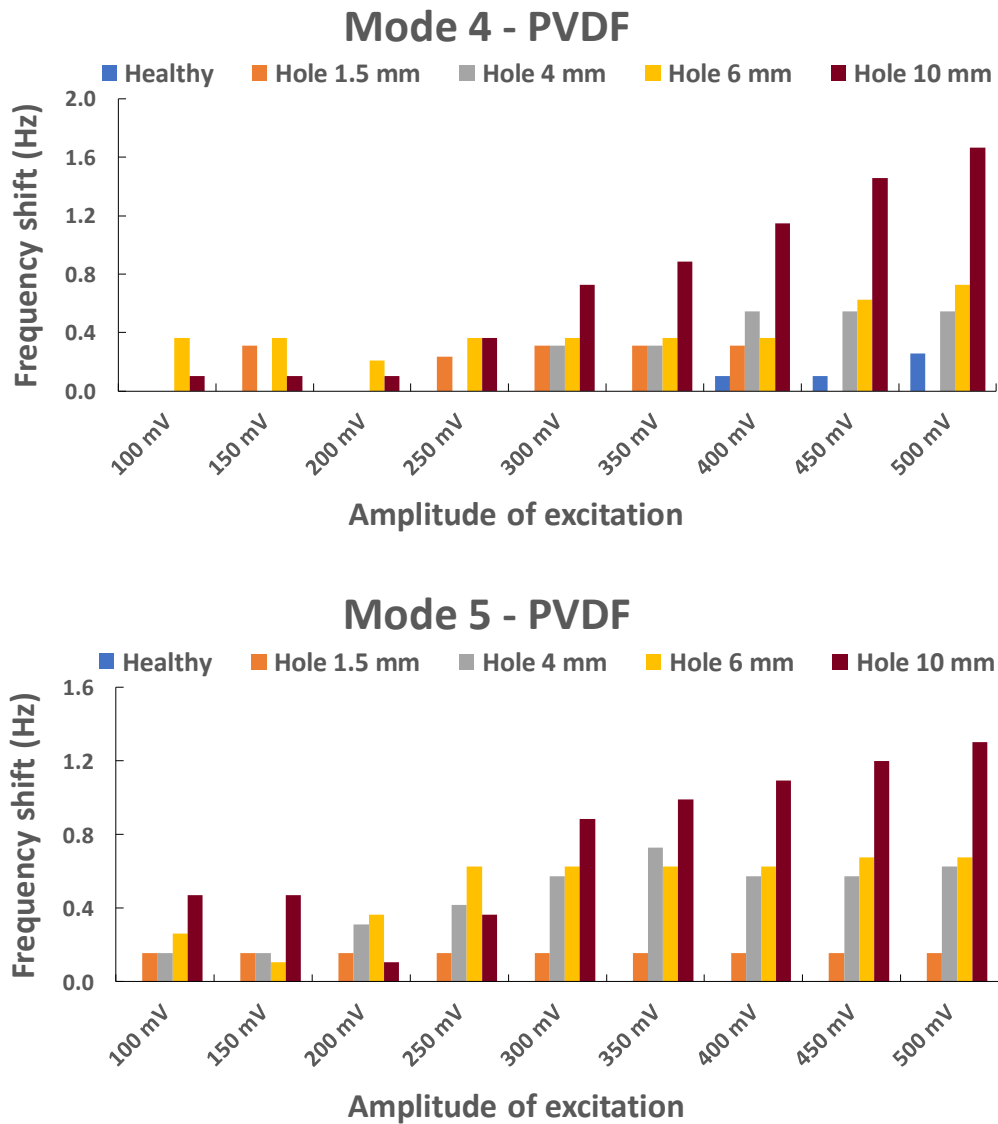
Figure 13. Evolution of the frequency shift in the fourth and fifth natural frequencies with an increasing hole diameter.

We recall that for this plate with incremental holes (1.5, 4, 6, and 10 mm), we will only study the response of the PVDF. Except for the first natural frequency, all the modes showed sensitivity to the presence of damage when it was greater than 4 mm in diameter. However, the fourth and fifth natural frequencies produced the best results (Figure 13). The vibration frequency offset increases with the increase of the excitation amplitude and the hole diameter, to reach significant values from 300 mV. It is clear that the 3 diameters of 4, 6, and 10mm generate more vibration frequency shifts than that of 1.5mm, especially in the 5th mode.

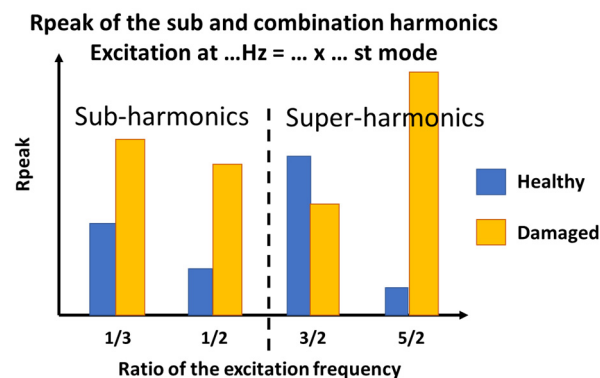
Figure 15. Histogram visualization and example for SFE method.

To visualize the influence of damage, a histogram showing the R_{peak} for each ratio of fundamental frequency excitation was created. The sub-harmonics 0.3/0.5 and the super-harmonics 1.5/2.5 were used. In order to visualize the ratio of the four plates, $R_{\text{peak}} (\%)$ is presented in a logarithmic scale (Figure 15).

In the example in Figure 15:

- The excitation frequency is 150 Hz = $1/2 \times 3$ rd mode (the 3rd mode natural frequency is 300 Hz);
- The sub-harmonics (1/3 and 1/2): R_{peak} is calculated from the amplitude of the output peaks at 75 and 50 Hz;
- The super-harmonics (1.5 and 2.5): R_{peak} is calculated from the amplitude of the output peaks at 225 and 375 Hz;

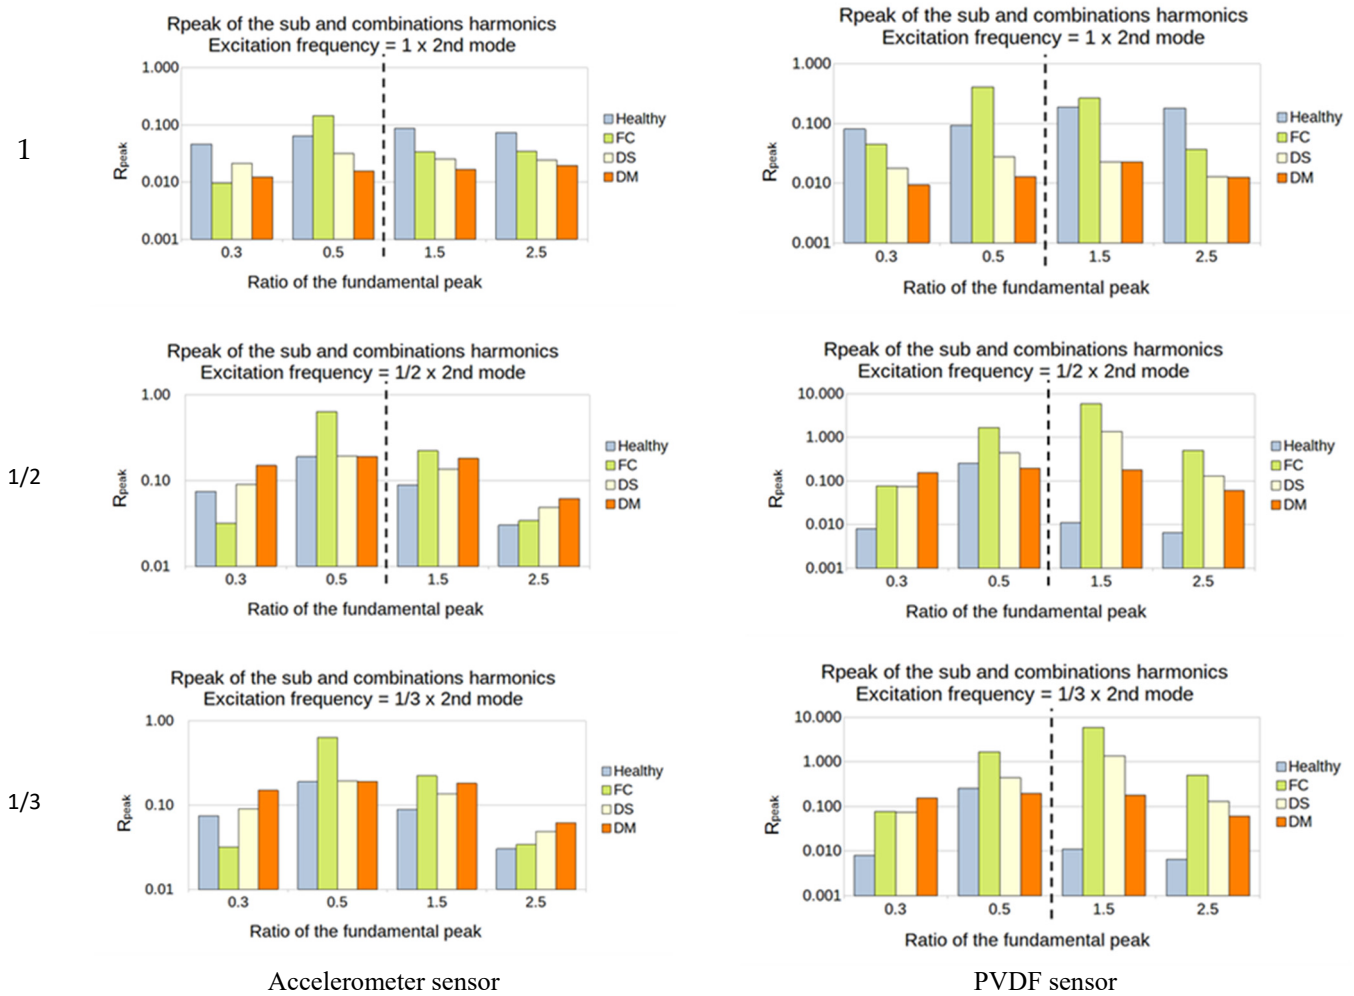
Figure 17. Second natural frequency and its ratio of 1, 1/2, and 1/3 as the frequency of excitation.

For the second natural frequency, the difference between healthy and damaged plates is smaller; indeed, only the FC plate showed a high sensitivity in almost all the cases. Another interesting thing is that the super-harmonics of 1.5 and 2.5 provide good results for the excitation frequencies of 1/2 and 1/3 for both sensors. No interesting results came out from the ratio of 1 (Figure 17).

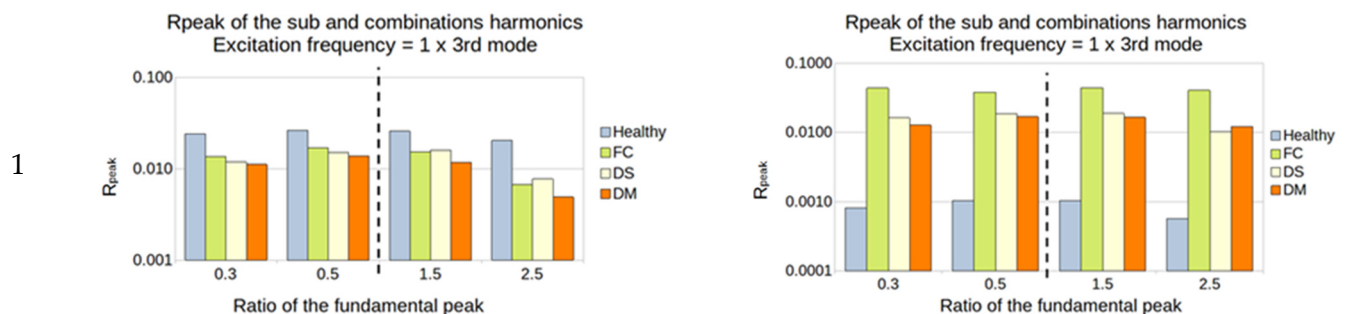
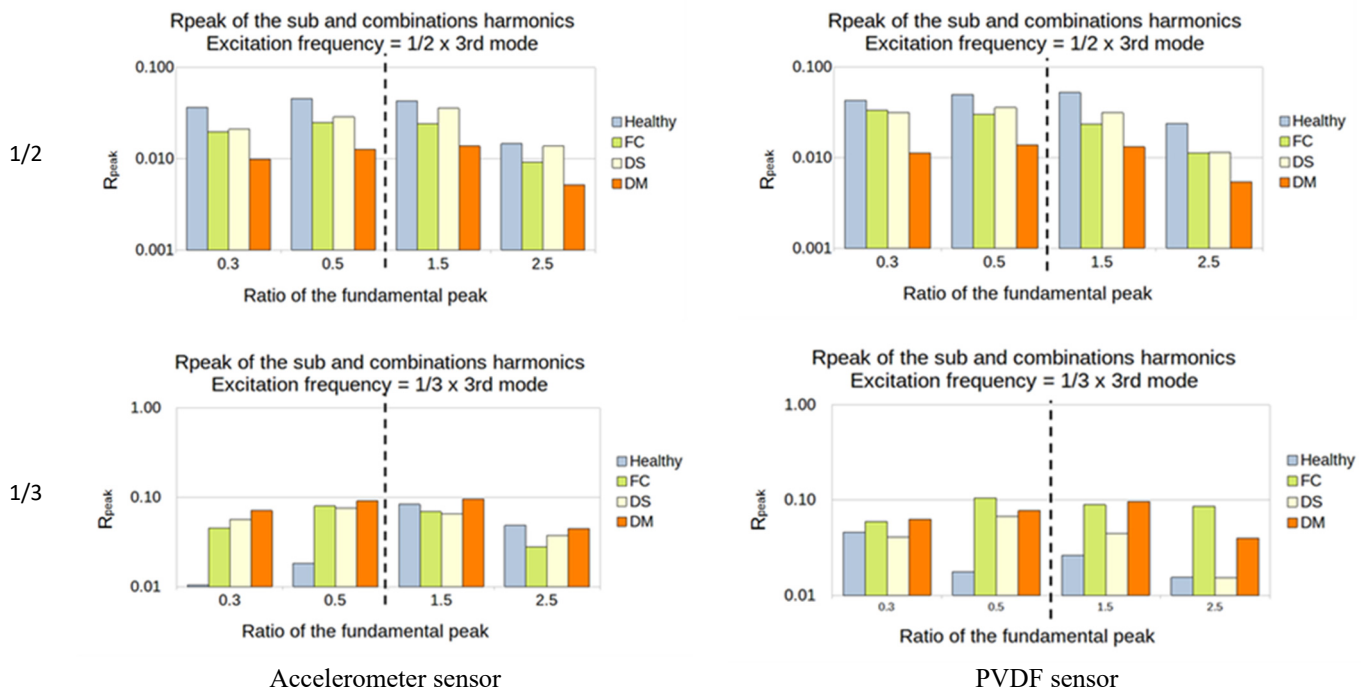
Figure 18. Third natural frequency and its ratio of 1, 1/2, and 1/3 as the frequency of excitation.

For the third natural frequency, the PVDF showed sensitivity in every sub- and super-harmonics generation for the 1 and 1/3 excitation, while the accelerometer showed sensitivity only for the 1/3. However, the value of the ratio was weak, between 0.01 and 0.1% (Figure 18).

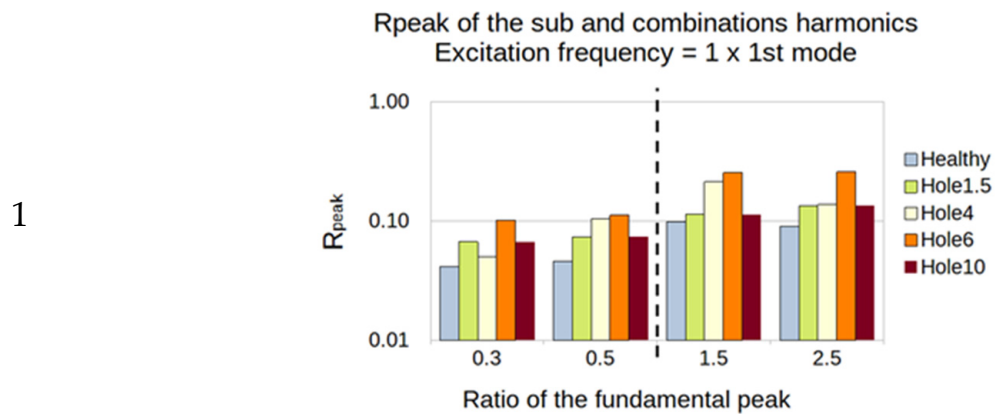
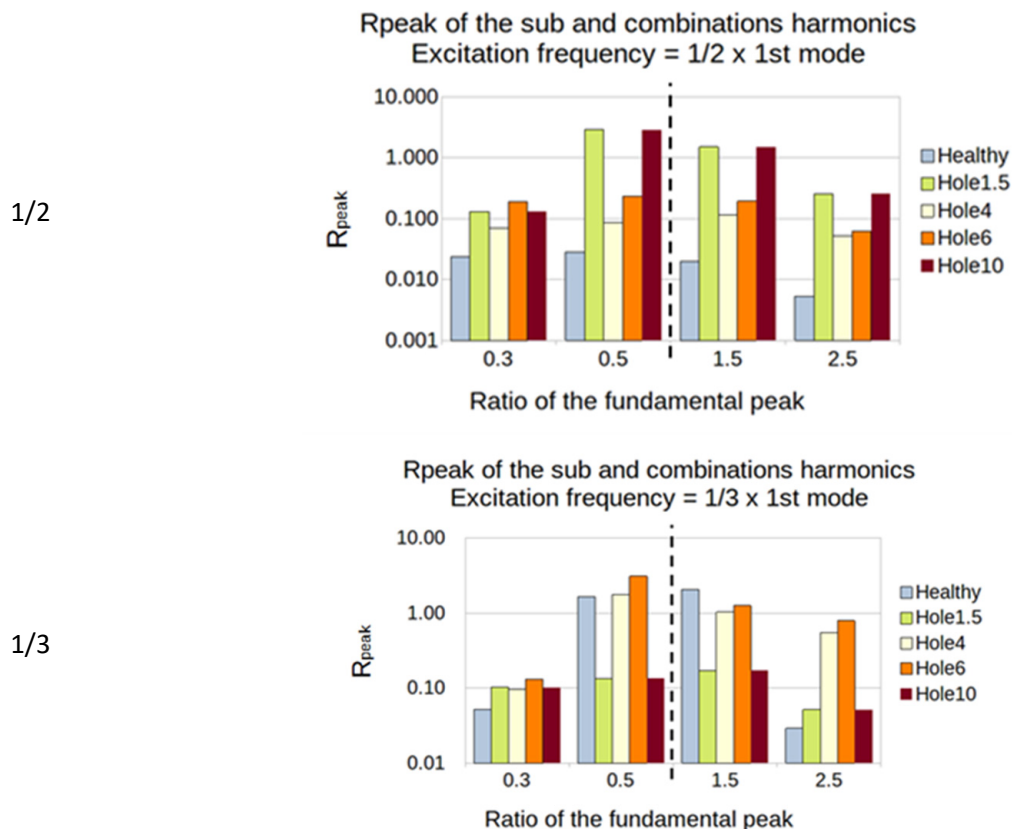
Figure 19. First natural frequency and its ratio of 1, 1/2, and 1/3 as the frequency of excitation for the PVDF sensor.

This is less clear for the hole than for the manufactured damage. However, for the first natural frequency, the ratio 1 of excitation showed sensitivity for every size of the hole and every sub- and super-harmonic. The ratio of 1/2 showed results, and the ratio of 1/3 did not show anything (Figure 19).

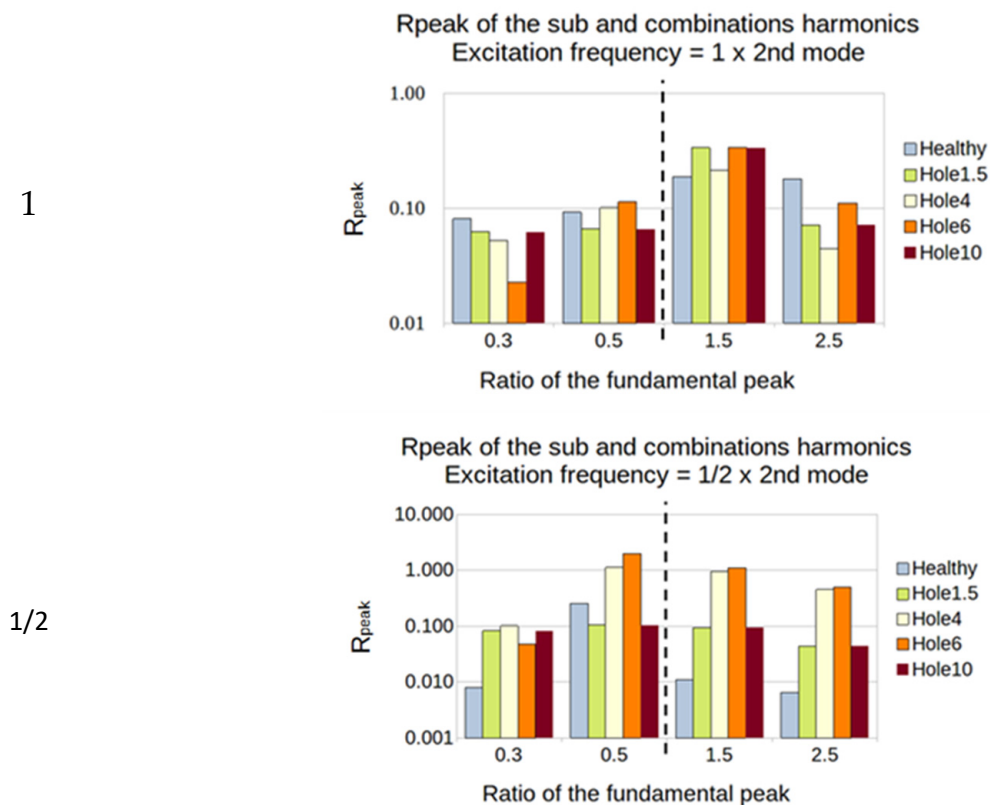
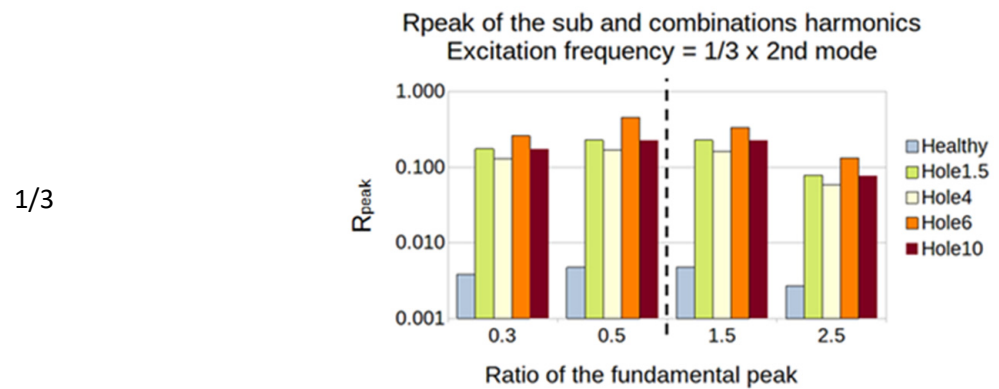
Figure 20. Second natural frequency and its ratio of 1, 1/2 and 1/3 as the frequency of excitation for the PVDF sensor.

For the second natural frequency, the PVDF showed a high sensitivity for ratio 1/2, especially on the super-harmonics. Both sensors showed a high sensitivity for the ratio of 1/3 for every size of the hole (Figure 20).

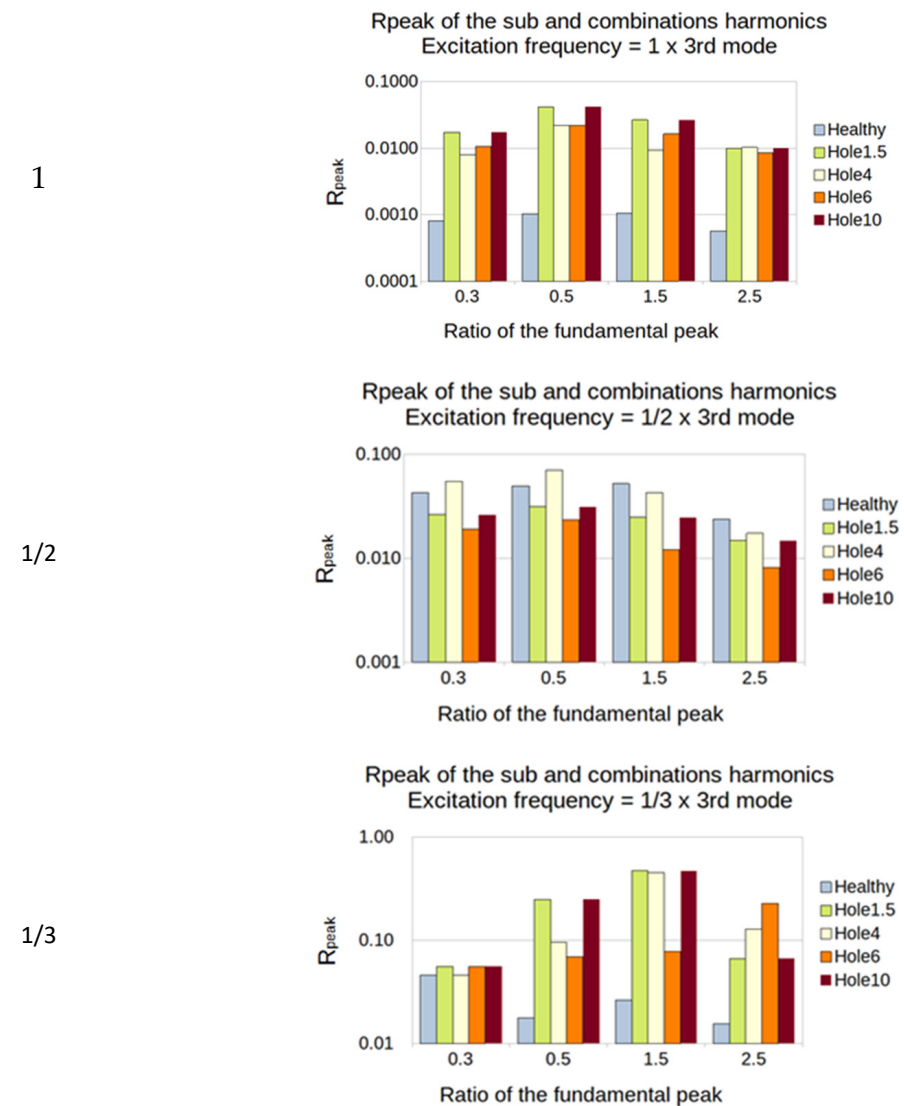
Figure 21. Third natural frequency and its ratio of 1, 1/2 and 1/3 as the frequency of excitation for the PVDF sensor.

For the third natural frequency, the PVDF showed a high sensitivity for the ratio of 1 and the ratio of 1/3, especially on the super-harmonics and the sub-harmonics 1/2 (Figure 21).
